Detecting Rogue GPS Antennas

Interference to GPS L1 Signal at a Data Centre

CASE STUDY

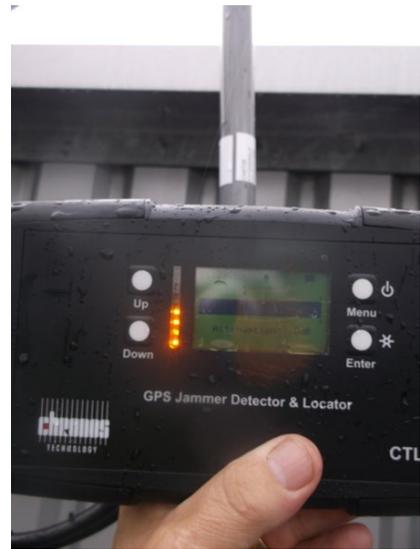
Chronos thought LD4's problem sounded similar to a GPS interference problem it had solved for another company using its CTL3520 (Fig 2) handheld GPS jammer and interference detector. The company had been experiencing poor GPS for months and although the antenna had been replaced several times, and the receiver and even the cable run from the antenna to the receiver, the problem kept recurring. Using the direction finding feature, which pinpoints the precise source of the interference, the CTL3520 identified a rogue GPS antenna on the first visit to the roof.

Figure 2: CTL3520 identifying the rogue antenna at LD4

Following discussions with Equinix, Chronos explained how the root cause of the interference could be determined quite quickly if it was a rogue antenna. As a result a Chronos engineer visited LD4 with the handheld jammer detector and a rogue antenna was identified (Fig 2) and decommissioned later that day after contacting the Equinix customer. Service levels were instantly improved and therefore the quality of service Equinix offers its customers.

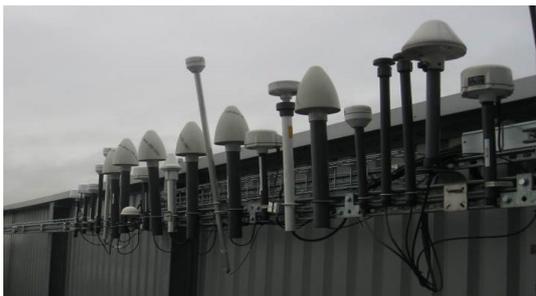
Figure 1: Which antenna?

This was a rogue GPS antenna at least 20 years old. When the native GPS signal is received from the sky it is amplified in the antenna. Poor connections can cause the now relatively powerful GPS signal to be reflected back through the antenna and turn it into a local jammer. This experience also showed that the safe distance to segregate adjacent GPS antennas is considerably underestimated. Some suggestions are that 2m distance between GPS antennas is OK. However, the faulty antenna was at least 20m away from the adjacent antennas.
