Detecting Rogue GPS Antennas

Interference to GPS L1 Signal at a Data Centre

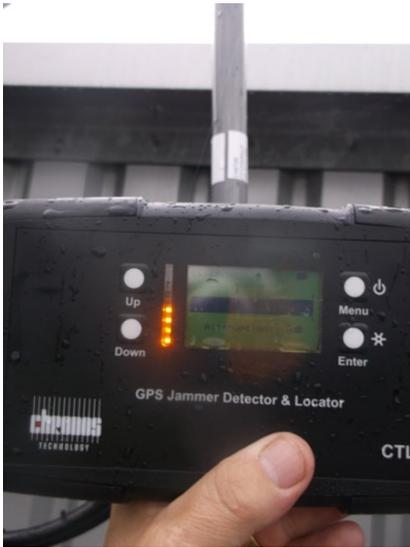
Figure 2: CTL3520 identifying the rogue antenna at LD4

Following discussions with Equinix, Chronos explained how the root cause of the interference could be determined quite quickly if it was a rogue antenna. As a result a Chronos engineer visited LD4 with the handheld jammer detector and a rogue antenna was identified (Fig 2) and decommissioned later that day after contacting the Equinix customer. Service levels were instantly improved and therefore the quality of service Equinix offers its customers.

This was a rogue GPS antenna at least 20 years old. When the native GPS signal is received from the sky it is amplified in the antenna. Poor connections can cause the now relatively powerful GPS signal to be reflected back through the antenna and turn it into a local jammer. This experience also showed that the safe distance to segregate adjacent GPS antennas is considerably underestimated. Some suggestions are that 2m distance between GPS antennas is OK. However, the faulty antenna was at least 20m away from the adjacent antennas.

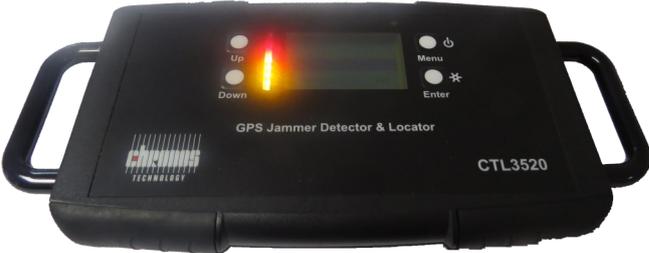
Figure 1: CTL3520 GPS Interference Detector

Chronos thought LD4's problem sounded similar to a GPS interference problem it had solved for another company using its CTL3520 (Fig 2) handheld GPS jammer and interference detector. The company had been experiencing poor GPS for months and although the antenna had been replaced several times, and the receiver and even the cable run from the antenna to the receiver, the problem kept recurring. Using the direction finding feature, which pinpoints the precise source of the interference, the CTL3520 identified a rogue GPS antenna on the first visit to the roof.
