## GNSS Jammer Observations:

### Setup:

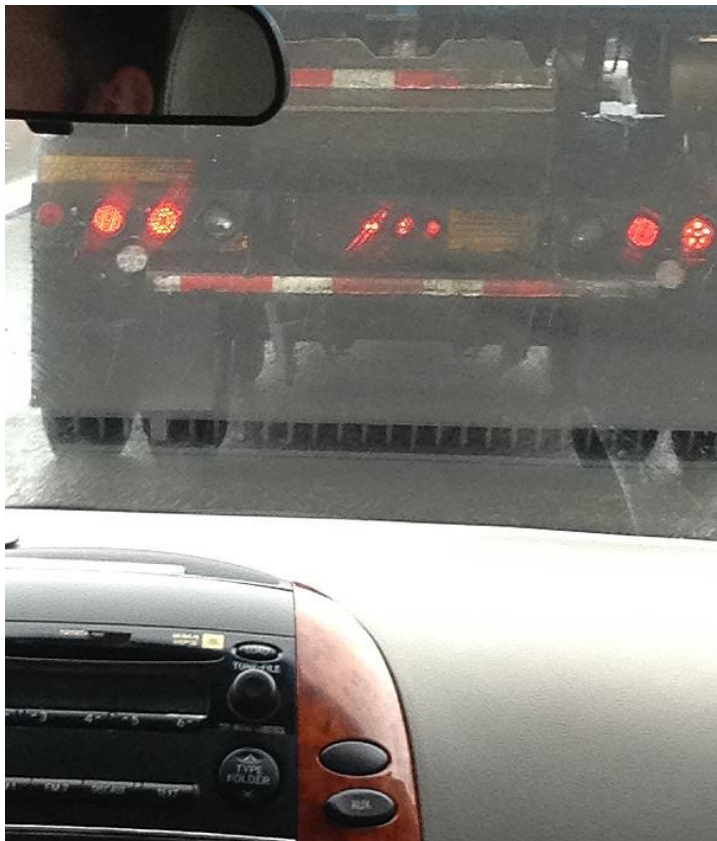
It was easy to associate this signal with a double tandem trailer truck driven by someone from our local waste management company here in Portland. We saw the signal similar to figure 3 for several minutes while the vehicle was trailed at a distance. The double tandem trailer was near 100' long.

Travelling behind the trailer for several minutes, the GNSS receiver never lost lock (jamming signal out of band a few MHz). When entering Highway I-5, it was now possible to move alongside the truck.

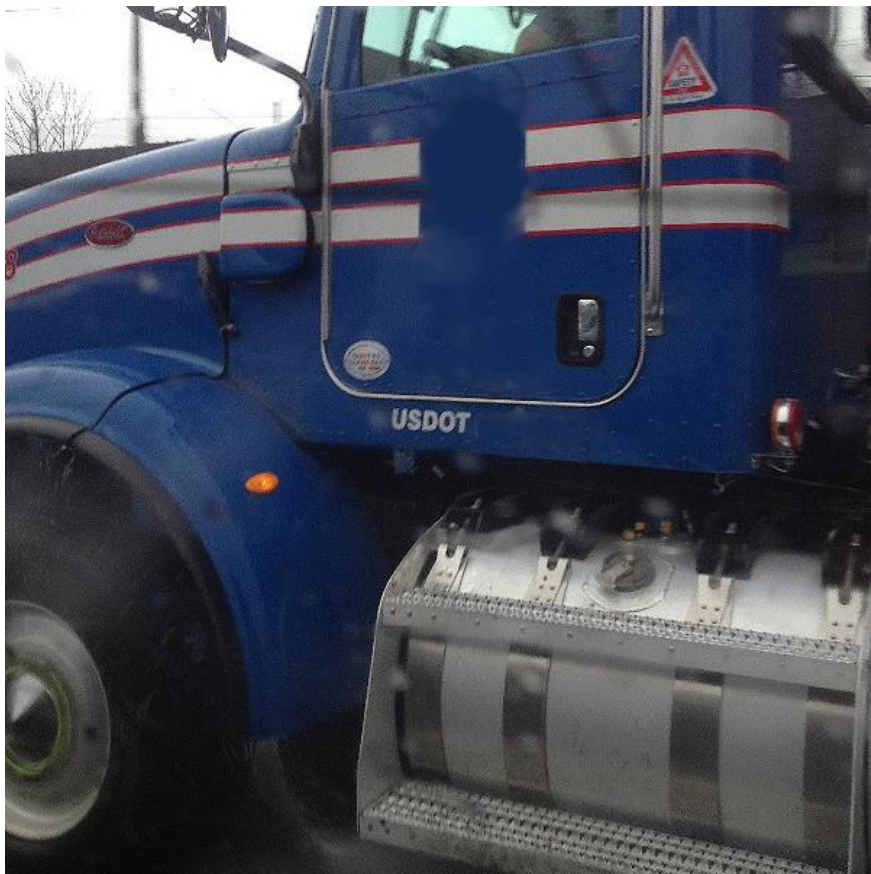
Collections continued along the trailer side in an open lane passing very slowly, it wasn't until reaching the first trailer that to lose GNSS satellites began to lose lock. Observing the difference between truck shadowing and RF jamming was now intuitive in the GNSS test receiver user interface. Then, the signal changed (Figure 4) ....again and again.
