(National Communications Authority)

Report

Background for the check

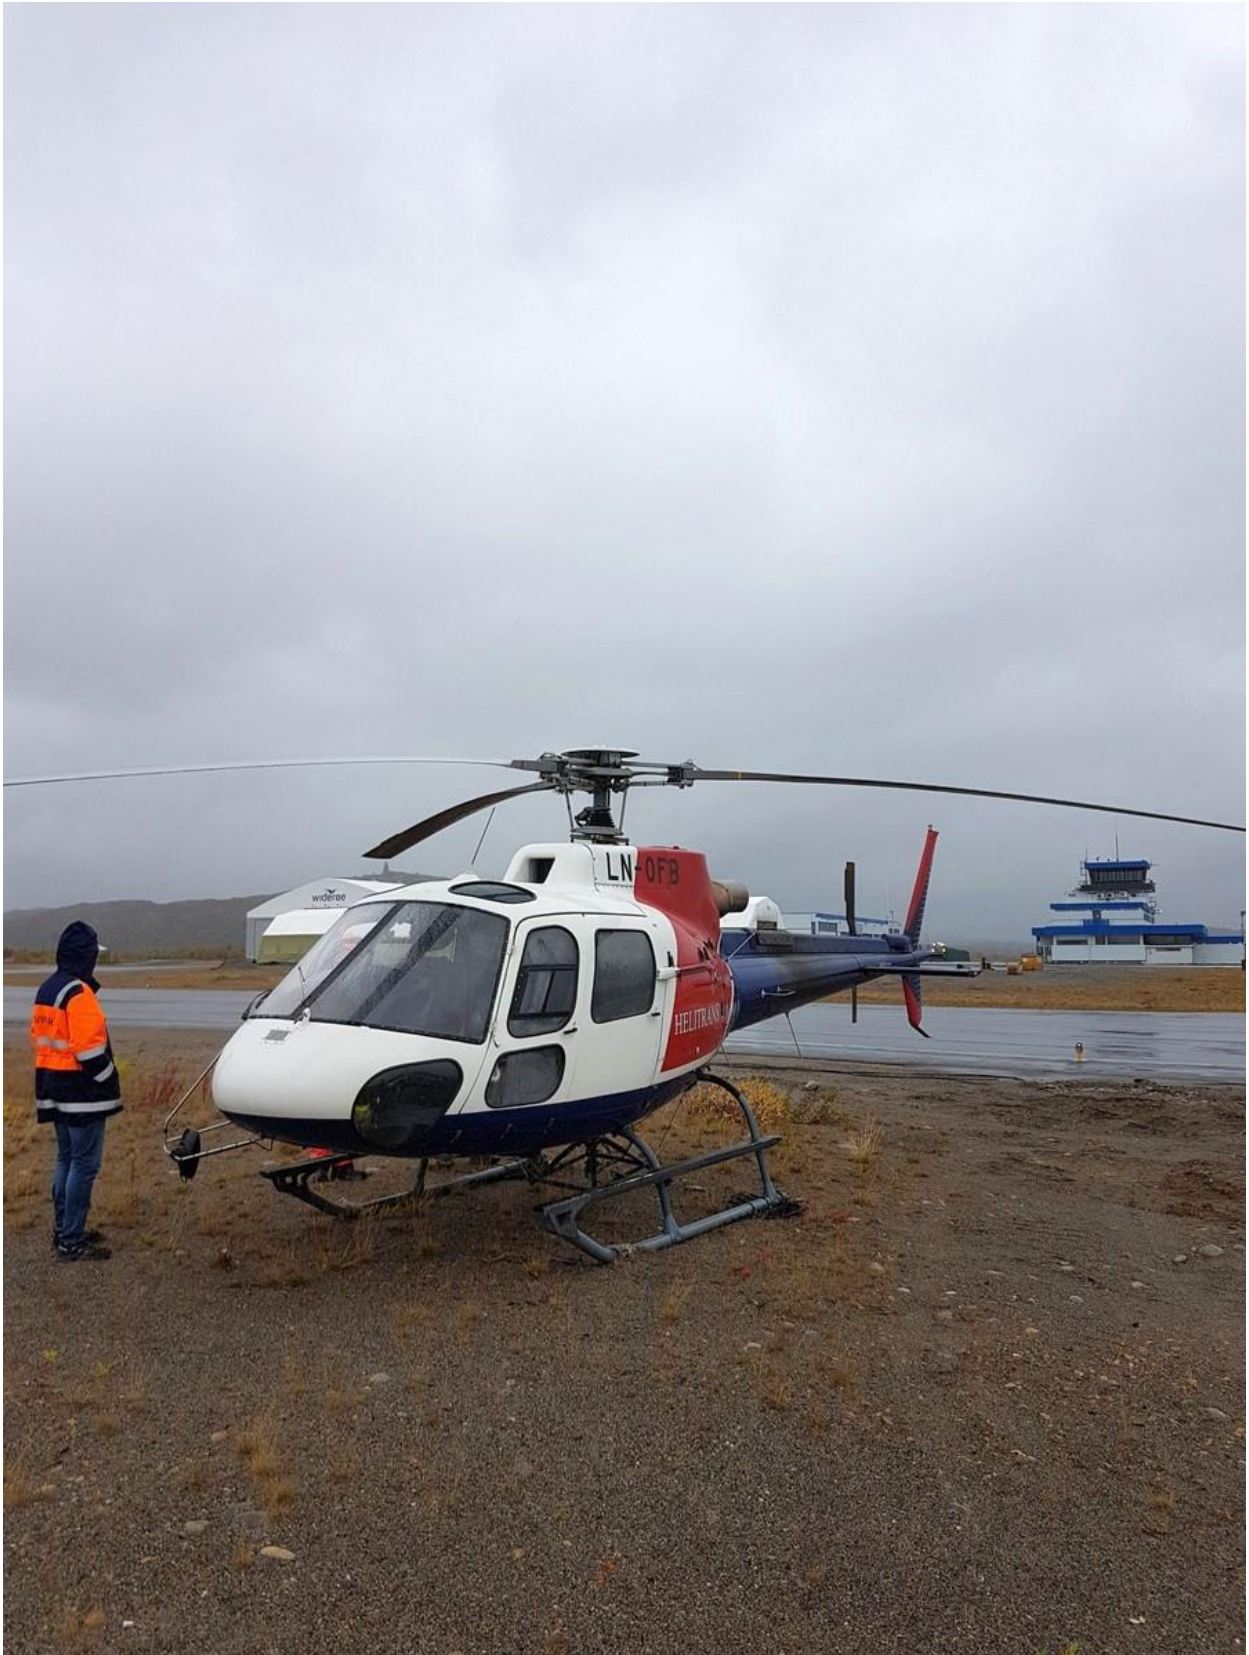
Figur 1. The helicopter used during the measurements.

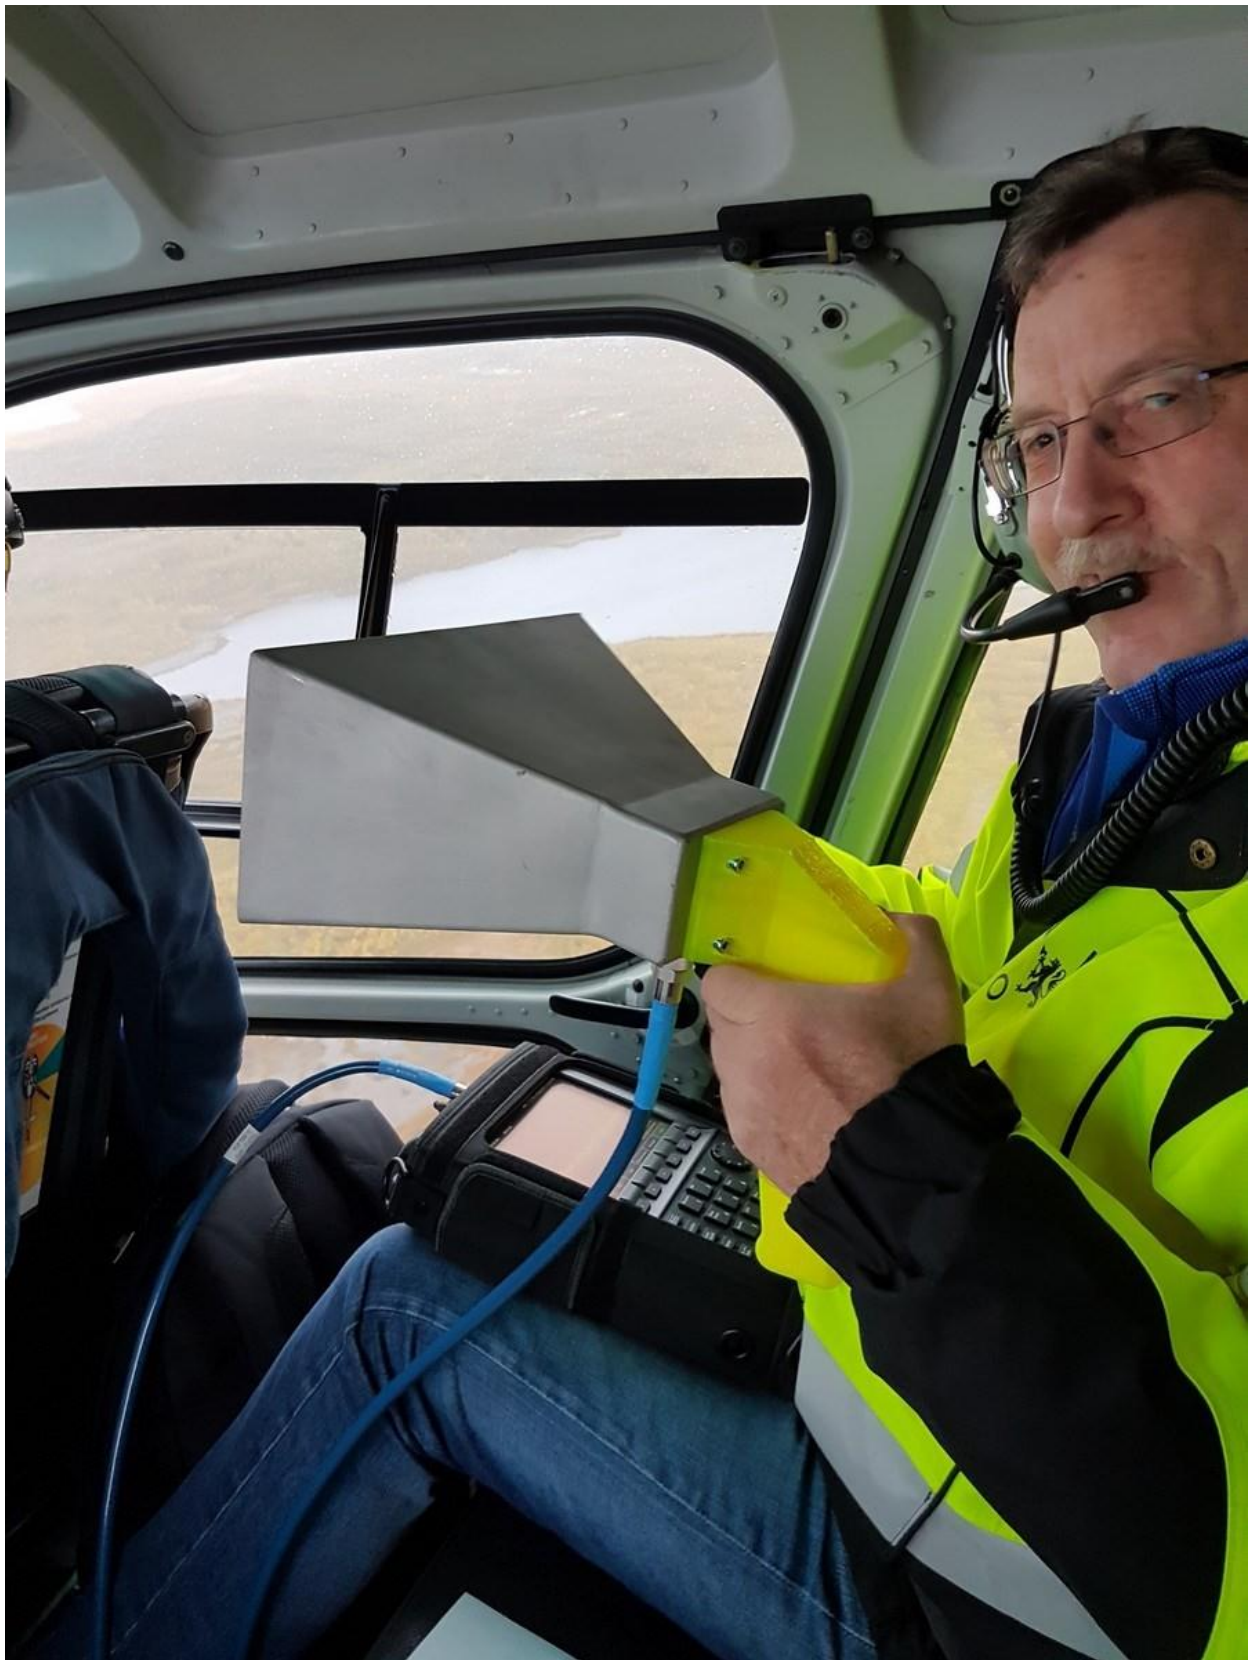
Figur 2. Picture of horn antenna and measuring instrument.

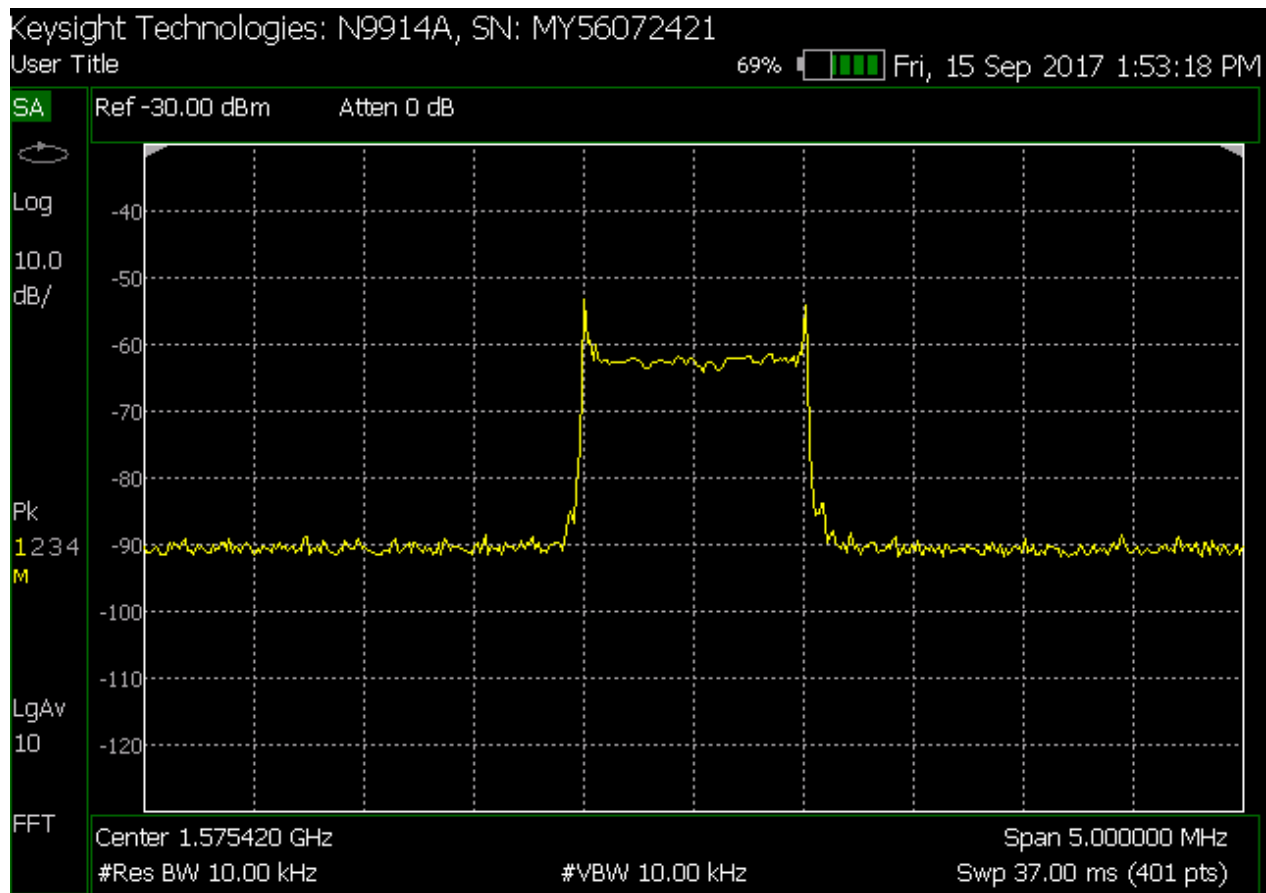
Figure 5. Plot of noise signal at 1575.42 MHz. Measured with Keysight Fieldfox N9914A. The bandwidth of the noise signal is 1 MHz.

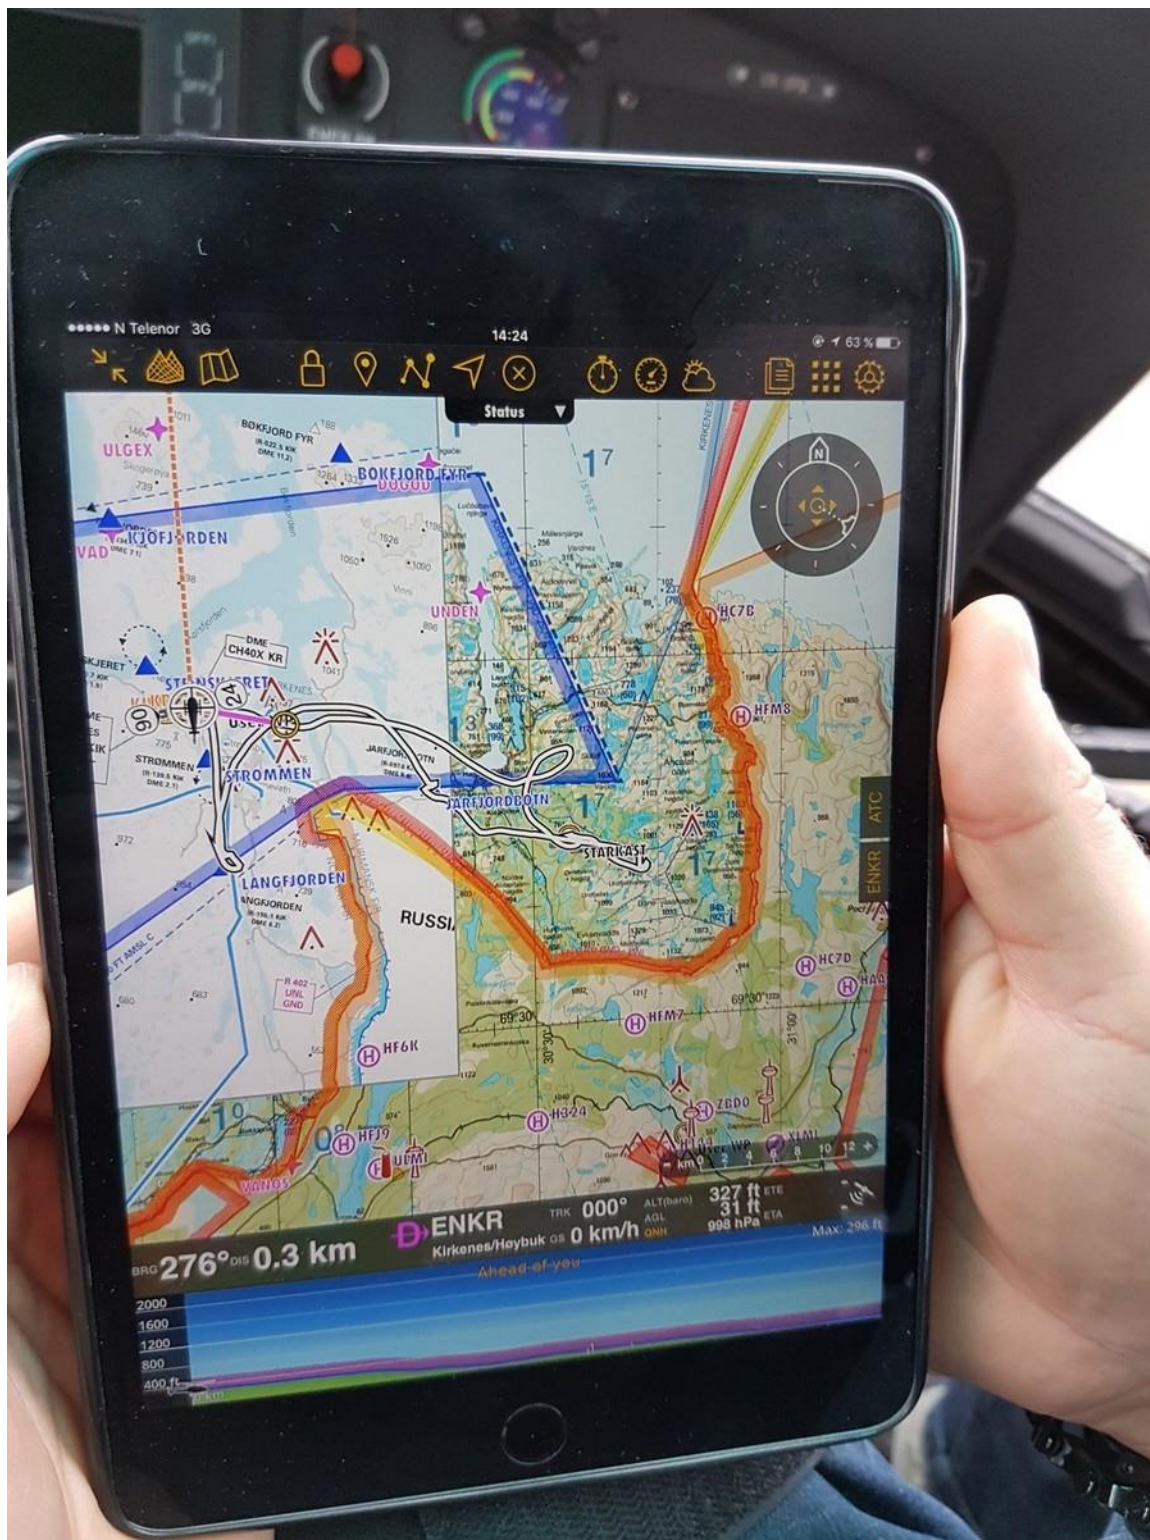
Figure 6. Picture of the Apple tablet to the pilot. The picture shows the entire route. Because of low cloud cover was maximum flown up to 1400 feet. The pilots could report that the helicopter lost GPS track during the flight, but the tablet did not. Probably, the tablet uses GLONASS.

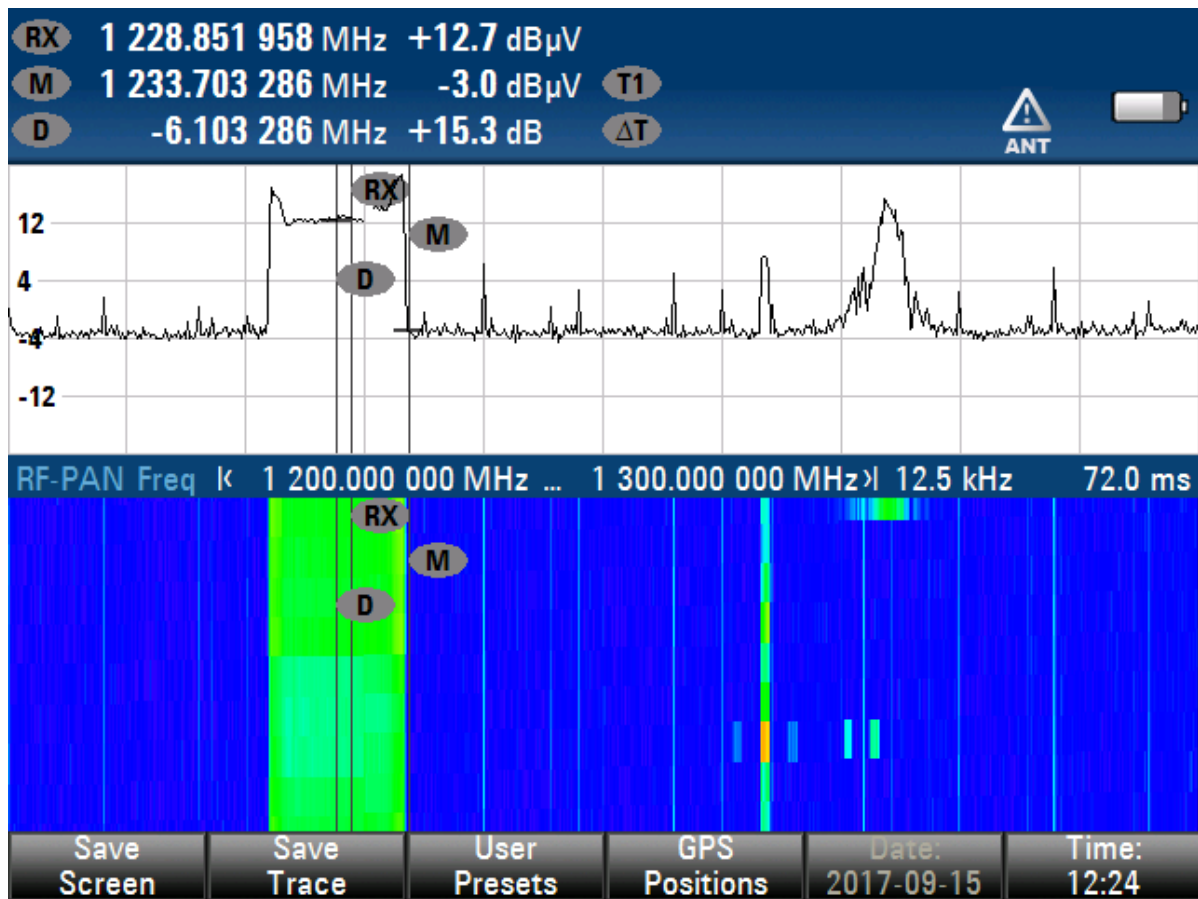
Figure 9. Plot of noise at 1227 MHz. Measured with Rohde & Schwarz PR100. The upper limit of the noise signal is 1233.7 MHz.
